# **Case Study**

## Antimicrobial Duct Coating Brisbane Public Hospital

Hospital (QLD Australia)

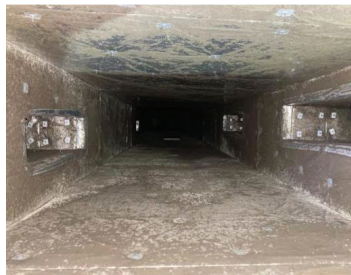
Image 1 - AHU4.1 Ductwork Before

Prior to treatment, comprehensive air quality testing and visual inspection revealed severe microbial contamination throughout the HVAC ductwork system. The before-treatment images (Images 1 and 3) document the extent of the deterioration:

- Heavy accumulation of dust, dirt, and organic debris along duct surfaces
- Dark discolouration indicating extensive mould growth throughout the duct interior
- Compromised insulation showing signs of moisture damage and microbial colonisation
- Visible biofilm development on duct linings, creating ideal conditions for bacterial and fungal proliferation

The LEFA (Low Emission Flexible Agitation) system was deployed for deep mechanical cleaning  
This advanced cleaning method physically removes debris, biofilm, and contamination without introducing harsh chemicals  
Mechanical sweeping and vacuuming eliminated loose particulates and organic material  
All dislodged contamination was captured using HEPA filtration systems

AerisGuard™ Surface Cleaner was applied to address embedded organic contamination  
AerisGuard™ Heavy Duty Degreaser was utilized in areas with oil or grease buildup that could compromise coating adhesion  
These pre-treatment products ensured optimal surface preparation for the final protective coating  
Surfaces were inspected to meet NADCA "clean" standards before coating application

Product was thoroughly mixed using electric drill with paintstirrer attachment for 10+ minutes to achieve consistent viscosity  
Application performed using high-pressure airless spray equipment (minimum 2,800 PSI capacity)  
Multiple thin coats applied rather than single thick coat, allowing proper drying between applications  
Application rate adjusted based on surface condition: 0.7-2.5 L/m<sup>2</sup> (standard surfaces), higher rates for damaged insulation  
Particular attention paid to sealing compromised lining and surface imperfections  
Black pigment option utilized in specific areas to provide visual discretion while maintaining antimicrobial properties

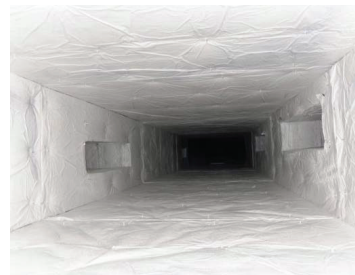
Image 2 - AHU4.1 Ductwork After

Coating allowed to cure with proper ventilation maintained throughout  
Visual inspection conducted to ensure complete, uniform coverage  
Photographic documentation captured post-application condition  
HVAC systems brought back online within 1-2 hours of coating completion  
No disruption to hospital operations or patient care during restart phase

AerisGuard™ Duct Coating & Sealant transformed critically contaminated ductwork into a pristine, protected system. The hospital achieved immediate air quality restoration with HVAC restart within one hour, enabling continuous patient care operations throughout the remediation process.
